AMMRC CR 70-20

DETERMINATION OF FLAWS IN AN 81 MILLIMETER PROJECTILE BODY USING THE
TRW ACOUSTO-OPTICAL IMAGING DEVICE

Robert Abrahamian

Final Report - Contract DAAG46-70-C-0043

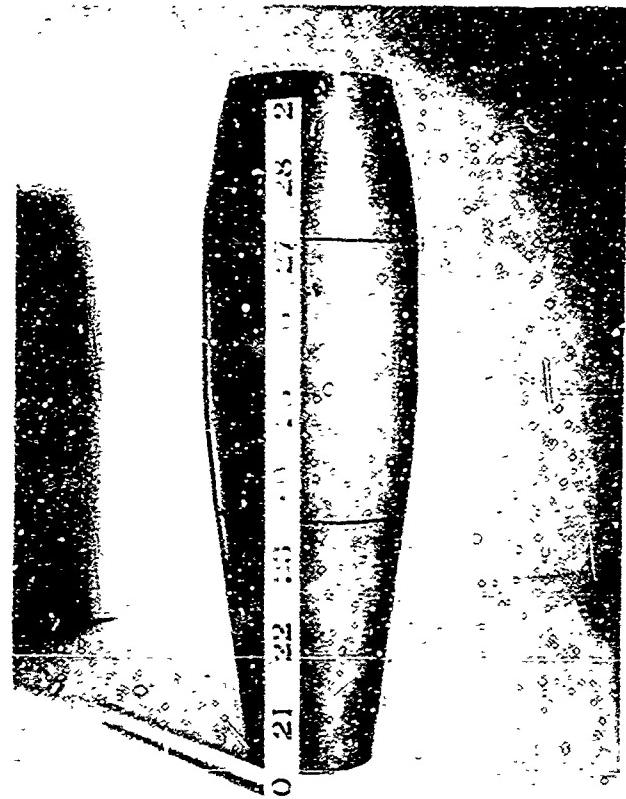
An 81mm shell containing three known flaws was supplied to TRW Systems by the Army Materials & Mechanics Research Center for use in this study. The shell contained two surface flaws (outer surface) and a crack (inner surface). The surface flaws are readily visible by naked eye while the crack is not. The Bragg Cell which was used in this study was not large enough to accommodate the 81mm shell as a single piece. Rather than building a new Bragg Cell, it was decided to section the 81mm into three parts. The sectioned shell (reassembled) is shown in Figure 8. Figure 9 shows the flawed sections individually. Sectioning the shell in this way does not affect the performance of the acousto-optical imaging device. Figure 9(a) shows the segment of the shell containing the crack. The crack is identified schematically by the dotted line. The two surface flaws exist on the outer surface of the shell segment shown in Figures 9(b) and 9(c). The maximum depth of these surface flaws were measured at AMMRC as .005 and .010 inches, respectively.

Figure 8 81 mm Shell Known to Contain Two Surface Flaws (Outer Surface) and a Crack (Inner Surface)

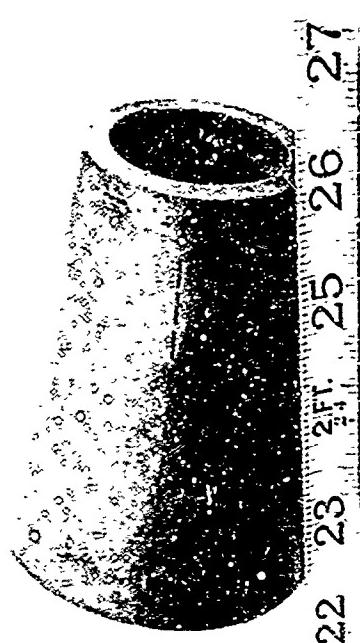
Figure 9 Sections of the 81 mm Shell Containing the Crack (a) and Two Surface Defects (b) and (c)

Figures 14(a), (b) and (c) show acousto-optical images of the known crack in the segmented section shown in Figure 9(a). The crack is known to be oriented along the longitudinal axis of the shell. The segment of the shell was placed into the Bragg Cell as shown schematically in Figure 11 with the crack running parallel with the light. Figure 14(a) was obtained using a 1" x 1-1/2" X-cut quartz crystal oscillating in its fundamental mode, 8 MHz. As with the surface flaws, the crack is shown as a darker area in the white background field of the transducer.

Figure 14(b) represents the acousto-optical image of the crack using a 1" x 1-1/2" crystal operating at 16 MHz. The specimen was deliberately rotated in the Bragg Cell so that the crack did not run along the optical axis but rather at an angle to it. The position of the transducer remained the same. This was done deliberately to determine the sensitivity of the alignment of the shell with respect to the transducer and optics. As one can see from Figure 14(b) the crack is still detectable. The internal machining marks are also pronounced at this frequency as they were in the case of the surface flaw studies. Figure 14(c) shows the acousto-optical image obtained of the crack using a 1" x 1-1/2" X-cut quartz crystal operating at 20 MHz. As in the case of the surface flaw studies, the rough turned machined finish became very pronounced at high frequencies. After the acousto-optical images of the crack were made, the 81mm projectile body was sectioned and examined microscopically for determination of both length and depth of the crack in the wall by AMMRC personnel. It was found to have a length of 1-1/4" and a maximum depth of 1/10" or half the wall thickness.

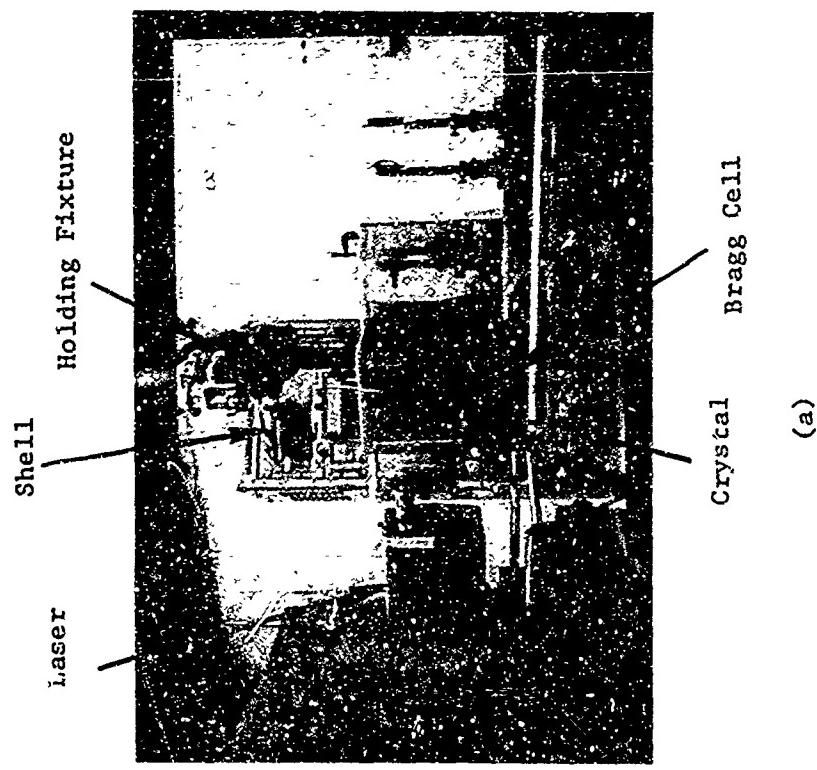
(a)

A special fixture was designed and built to handle the shell in the Bragg Cell of the Acousto-Optical Imaging device. The fixture has the capability of translating and rotating the shell in the Bragg Cell. Figures 10(a) and (b) show one segment of the shell held by the fixture outside and inside of the Bragg Cell, respectively. The capability to both rotate and translate the shell is necessary so that the entire shell case can be conveniently inspected.

Figure 10 Relationship between the optical axis, acoustic crystal and shell segment.

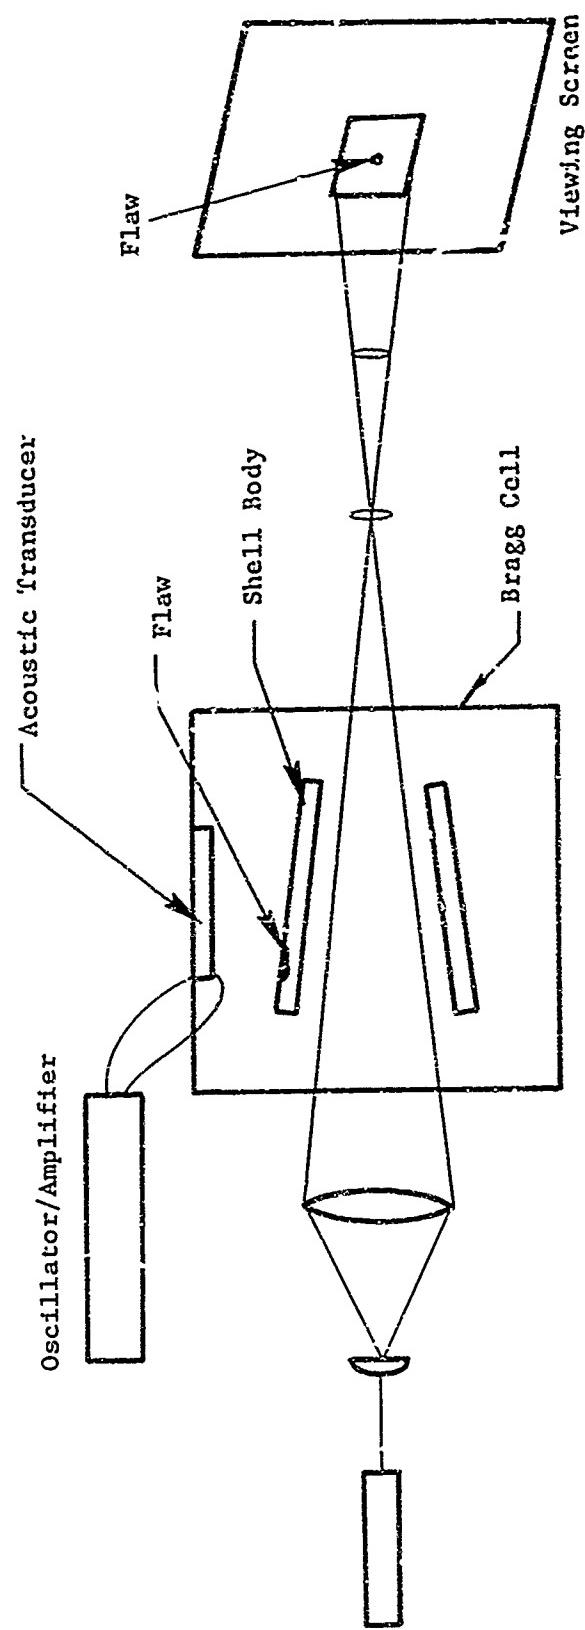
Figure 11 Schematic showing the orientation of the shell casing with respect to the acoustic transducer and laser light.

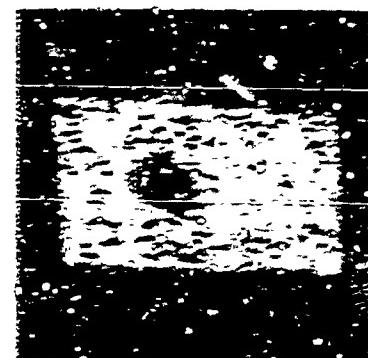
Figures 12(a), (b) and (c) show the acousto-optical images obtained of the surface flaw shown in Figure 9b at 8, 12 and 16 MHz respectively. The shell segment was inserted into the Bragg Cell by the specially designed fixture and assumed the position shown schematically in Figure 11.

Figure 12(a) was obtained using a 1" x 1-1/2" X-cut crystal operating in its fundamental mode, 8 MHz. The white background represents the crystal background. The flaw is shown as a darkened region in the field of the transducer. Figure 12(b) was obtained using a 1" x 1" X-cut quartz crystal (4 MHz fundamental) operating in its third harmonic (12 MHz). The dark central area represents the surface flaw. Careful examination of Figure 12(b) reveals the presence of faint horizontal lines which were not present in Figure 12(a). They are assumed to be caused by the rough turned machine finish (250 microinch surface roughness). At this higher frequency (12 MHz vs. 8 MHz) the acoustic wavelengths are shorter, resulting in better resolution and making the rough turned machined finish susceptible to imaging. Figure 12(c) was obtained using a 1" x 1-1/2" X-cut quartz crystal (8 MHz fundamental) operating in its second harmonic, 16 MHz. As with the previous two images, the dark area in the field of the transducer background represents the surface flaw. At this higher frequency the rough turned machined finish became more evident.

Figure 12 Acousto-Optical Images of the Surface
Flame Shown in Figure 9(b) Taken at

- a) 8 MHz
- b) 12 MHz
- c) 16 MHz

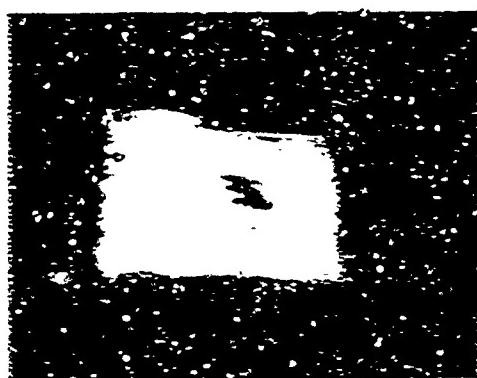
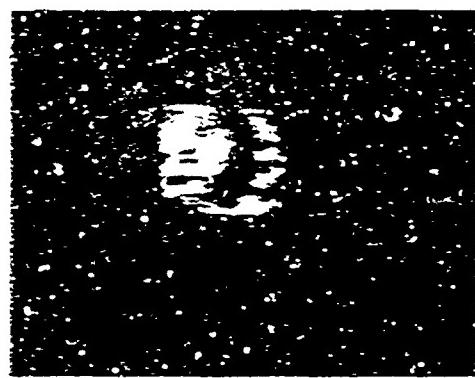
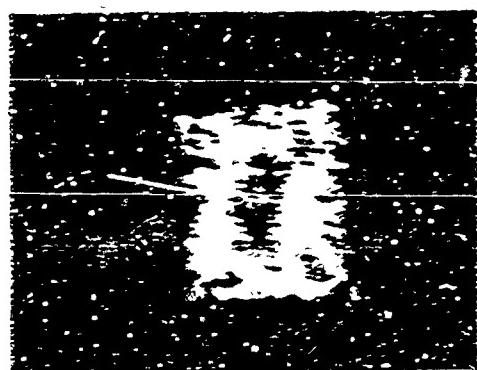
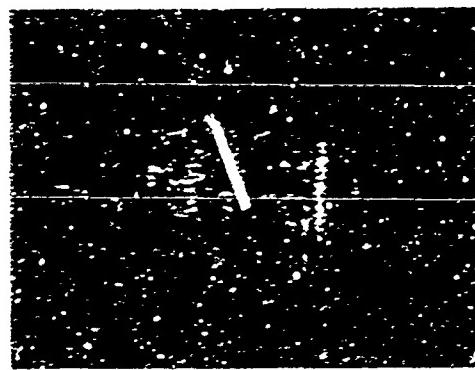
Figures 13(a), (b) (c) and (d) show acousto-optical images obtained of the surface flaw shown in Figure 9(c) at 8, 12, 16 and 20 MHz,

Figure 13. Acousto-optical Images of the Surface Flow Shown in Figure 9(c) Taken at

- (a) 8 MHz
- (b) 12 MHz
- (c) 16 MHz
- (d) 20 MHz

respectively. The section of the shell which contained the flaw was oriented in the Bragg Cell as shown in Figure 11.

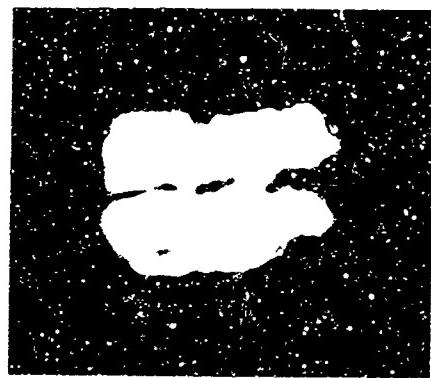
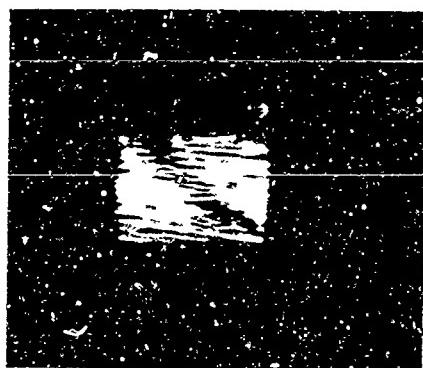
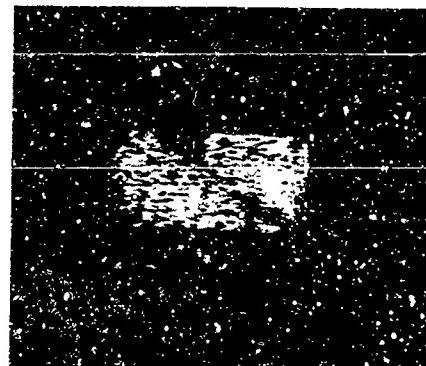
Figure 14 Acousto-Optical Images of the Crack in Shell Specimen Shown in Figure 9(a) Taken at

- a) 8 MHz
- b) 16 MHz
- c) 20 MHz

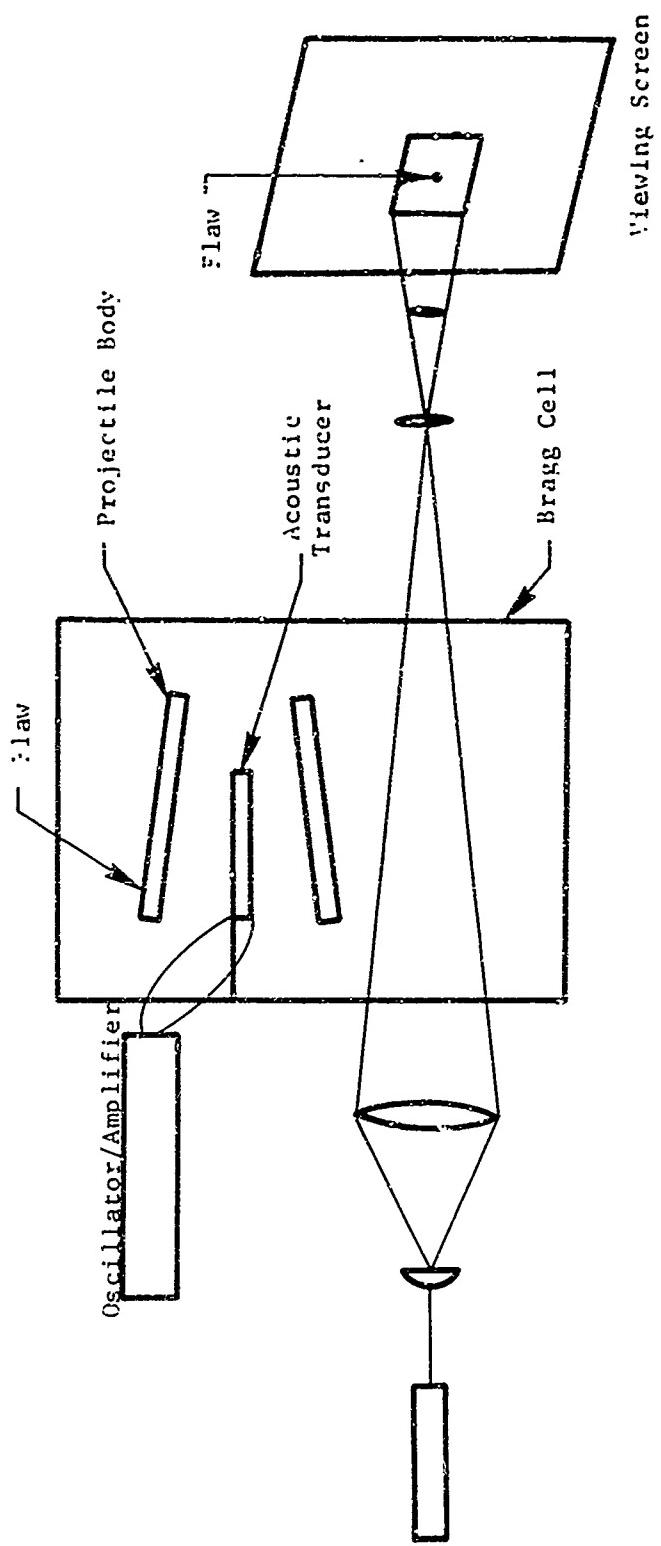
In some instances, e.g., when the shell is plugged at one end, one cannot send light through the bore. To show that comparable images may be obtained in these cases a second test procedure was used to obtain an acousto-optical image of the crack. This procedure consisted of inserting the acoustic transducer inside the bore of the projectile body rather than externally as described previously. The experimental setup is shown in Figure 15. One image of the crack was obtained in this manner. The frequency of the acoustic waves was 8 megacycles. The acousto-optical image of the flaw is shown in Figure 16. Comparing Figure 16 with Figure 14(a) shows that the resulting image obtained by this procedure is comparable with having the transducer external to the bore.

Figure 15 Schematic showing the orientation of the projectile body with respect to the acoustic transducer and laser light when it is not possible to send sound through the bore of the shell.

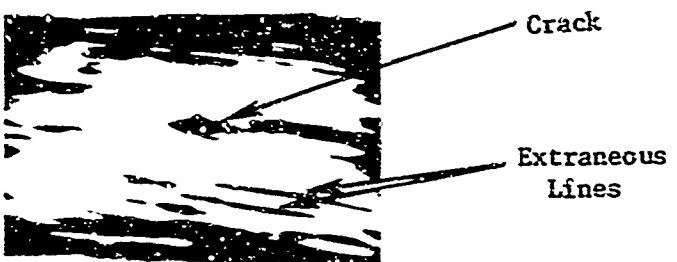
Referring to Figure 16, it can be seen that extraneous black lines appear across the face of the transducers. It is felt that these are due to the nonuniformity of the acoustic beam near its periphery. These lines can be distinguished from the flaw by rotating the shell. In so doing, the image of the flaw moves while these extraneous lines do not.

Figure 16 Acousto-optical image of the crack in the 81mm projectile body. The crystal was placed in the bore of the shell
